DEPARTMENT OF TRANSPORTATION**DIVISION OF ENGINEERING SERVICES**

Contract #: 04-0120F4Cty: SF/ALA Rte: 80 PM: 13.2/13.9File #: 1.28**WELDING INSPECTION REPORT****Resident Engineer:** Casey, William**Address:** 333 Burma Road**City:** Oakland, CA 94607**Report No:** WIR-026813**Date Inspected:** 03-Dec-2011**Project Name:** SAS Superstructure**OSM Arrival Time:** 700**Prime Contractor:** American Bridge/Fluor Enterprises, a JV**OSM Departure Time:** 1530**Contractor:** American Bridge/Fluor Enterprises, a JV**Location:** Job Site**CWI Name:** Fred Von Hoff**CWI Present:** Yes No**Inspected CWI report:** Yes No N/A**Rod Oven in Use:** Yes No N/A**Electrode to specification:** Yes No N/A**Weld Procedures Followed:** Yes No N/A**Qualified Welders:** Yes No N/A**Verified Joint Fit-up:** Yes No N/A**Approved Drawings:** Yes No N/A**Approved WPS:** Yes No N/A**Delayed / Cancelled:** Yes No N/A**Bridge No:** 34-0006**Component:** OBG Sections**Summary of Items Observed:**

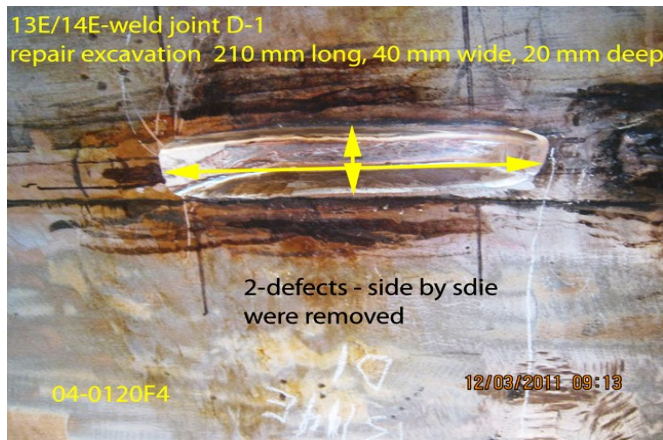
and ran for the same length. This QA Inspector observed QC Inspector John Pagliero perform a visual and Magnetic Particle Testing (MT) inspection on the completed excavation area, which measured; 210 mm long, 40 mm wide and 20 mm deep. This QA Inspector was informed he had accepted both inspections prior to performing a visual verification of the excavation, see photo below. This QA Inspector observed the liquid induction heating system had been formed into a coil and placed on the base metal above to provide the preheat and post heat. This QA Inspector verified the preheat was greater than 325°F with a temperature indicating marker prior to the start of welding. This QA Inspector observed QC Inspector John Pagliero verify the following Shielded Metal Arc Welding (SMAW) parameters for ABF welding personnel Wai Kitlai (#2202); 130 amperes. This QA Inspector observed a 3.2 mm diameter E7018H4R electrode was being used in the overhead (4G) position. The welding observed appeared to comply with ABF-WPS-D15-1004 Repair being used by the QC Inspector. This QA Inspector periodically monitored the work at this location. This QA Inspector observed the induction heating equipment had been set for 540°F, which exceeds the minimum but not the maximum temperature for the Post Weld Heat Treatment (PWHT). This QA Inspector verified with QC Inspector Fred Von Hoff, who was monitoring the PWHT, the base metal was within the required range of 450 to 600 degrees F. This QA Inspector observed the PWHT was maintained approximately 1-1/2 hours this shift. The base metal thicknesses range from 30 to 35 mm at this weld joint. The overall work observed at this location appeared to comply with ABF-WPS-D15-1004 Repair being used by the QC Inspector. This QA Inspector observed the repair welding and PWHT were completed this shift.
